Safety Warning

26th May 2009

Printing Press Guarding

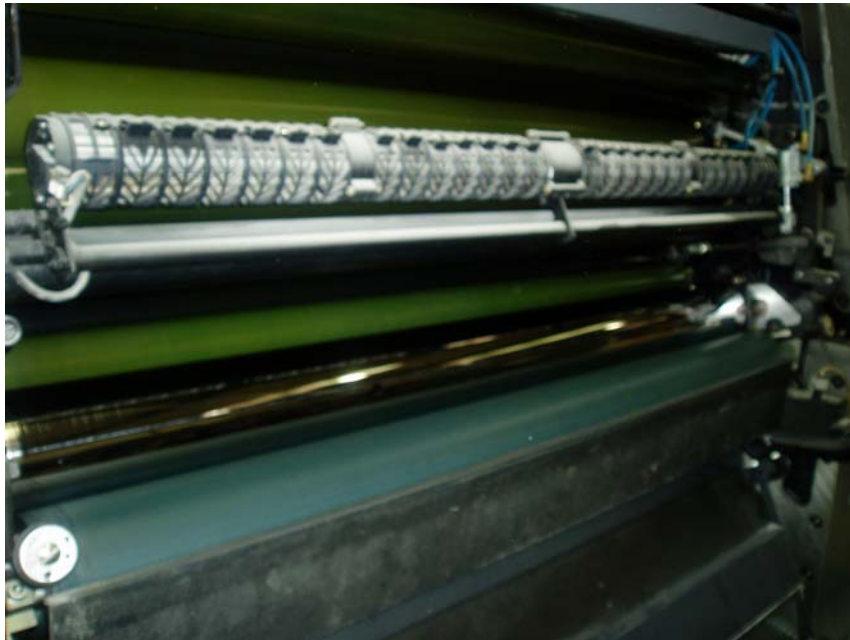
Guard between dampening and inking rollers

It is believed that the guarding of the machine was inadequate, and that at each print unit the extension guard which normally sits below the "guard in front of the inking unit at the feeder side" was missing.

Subsequent to lifting this guard it has to be hooked onto the closed guard. Thus both hands are free to insert/remove rollers. When opened the press can neither be inched nor run. This guard is designed in such a way that hickies can be removed from the plate while the press is in operation using a specially designed tool.

It appears that this machine was in operation with a guard missing at feed side of each print unit. The machine had probably been in this condition since it was installed second-hand in about 2003.
